# MERIAM HOUSE

Minute Man National Historical Park  
Concord, Massachusetts

## Historic Structure Report

Barbara A. Yocum, Architectural Conservator  
Historic Architecture Program, Northeast Region  
National Park Service  
Lowell, Massachusetts

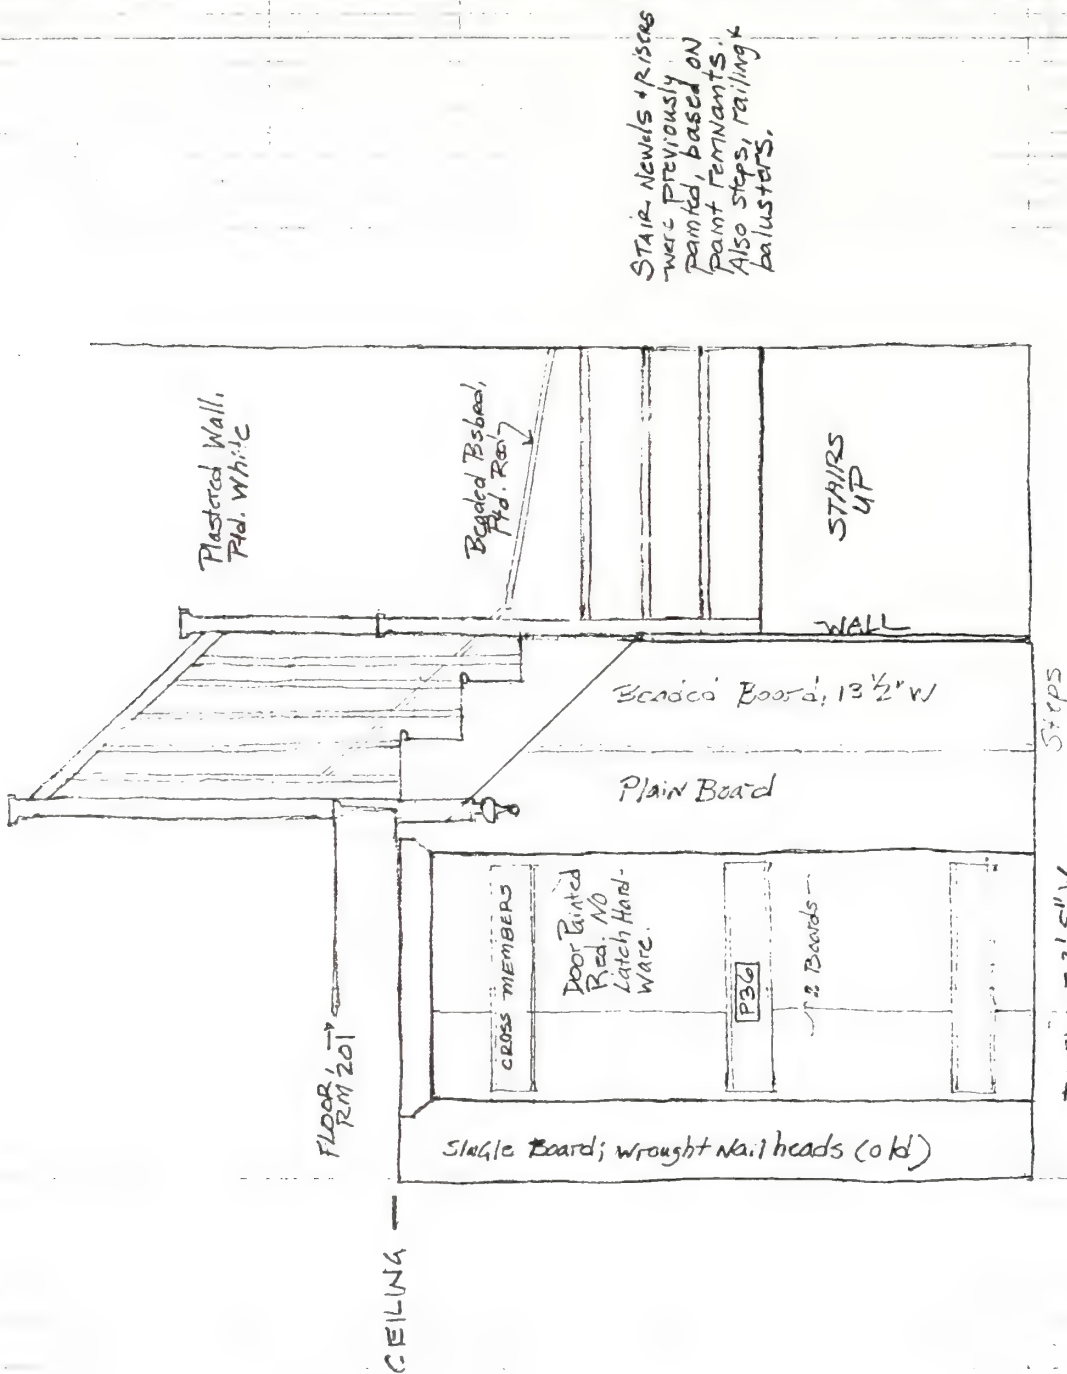
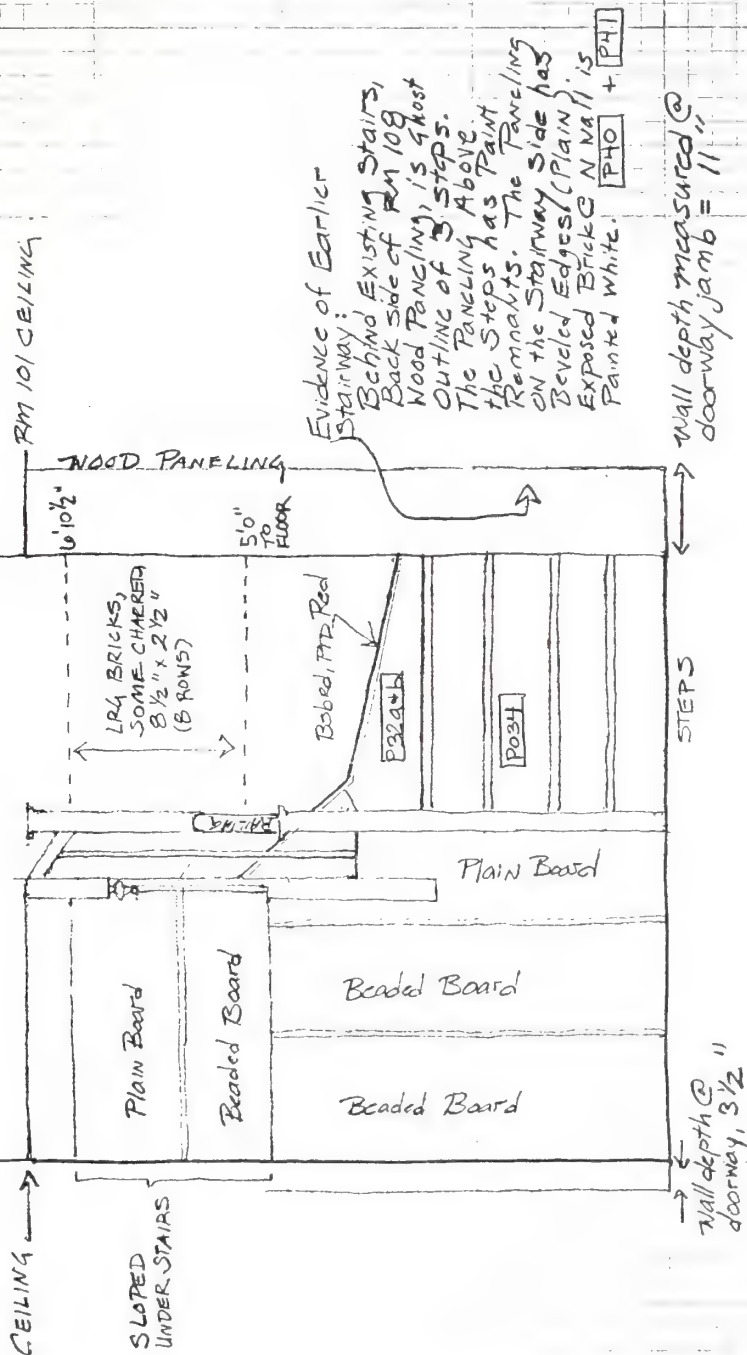
TMMA: MERIAM HS  
RM 101, NORTH WALL  
Aug. 9, 1993; B. Yocum

Steps

Doorway = 2'5" W  
6'4" H

Exposed Brick  
Wall, Red White.  
Note that some  
bricks are reused  
(chained), & the  
wall was previously  
plastered.

Mostly smaller  
bricks,  $7\frac{1}{2}" \times 2\frac{1}{2}"$   
(also lower wall)

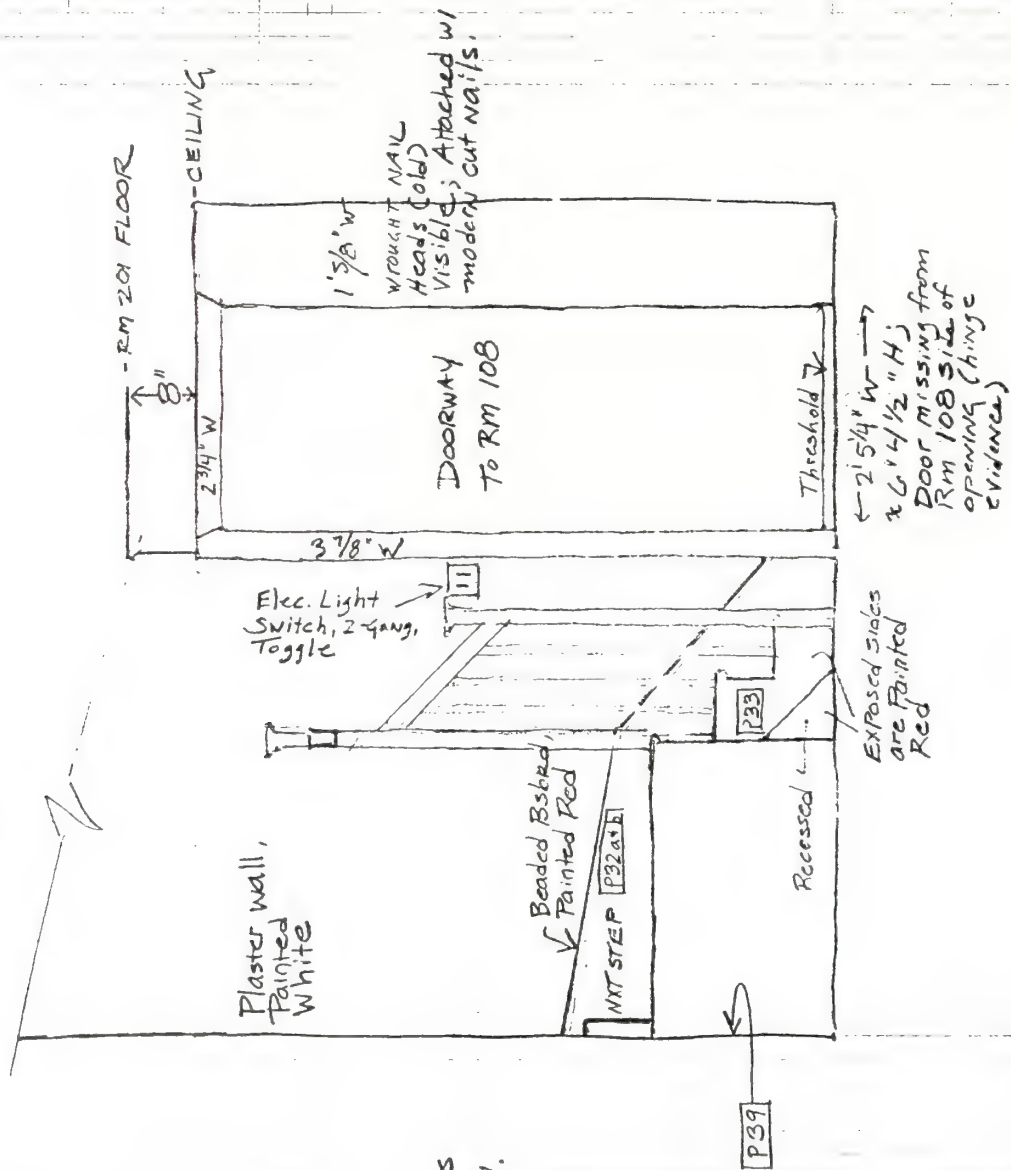
NOTE: All Woodwork is unpainted except Bsbnd, which is Red.

MJMA: MERIAM HS  
 RM 101, EAST WALL  
 Aug 9, 1993; B. Youm  
 SCALE: 1/2" = 1'0"

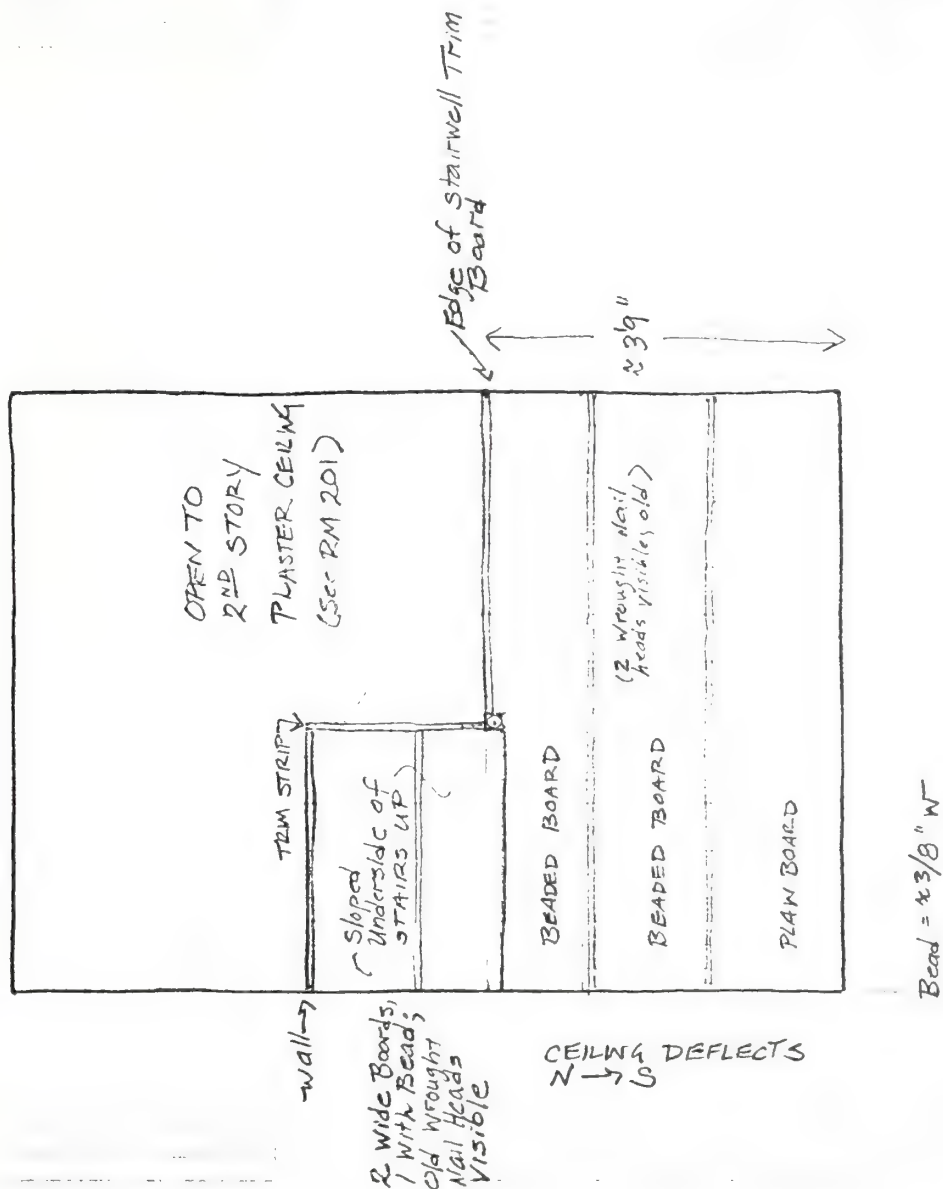
MIMA: MERIAM HS.  
RM 101, CEILING  
Aug. 9, 1993; B. Yacum  
SCALE: 1/2" = 1'0"

PAINT LINE  
ON N WALL  
INDICATES NO  
STEP UP HERE

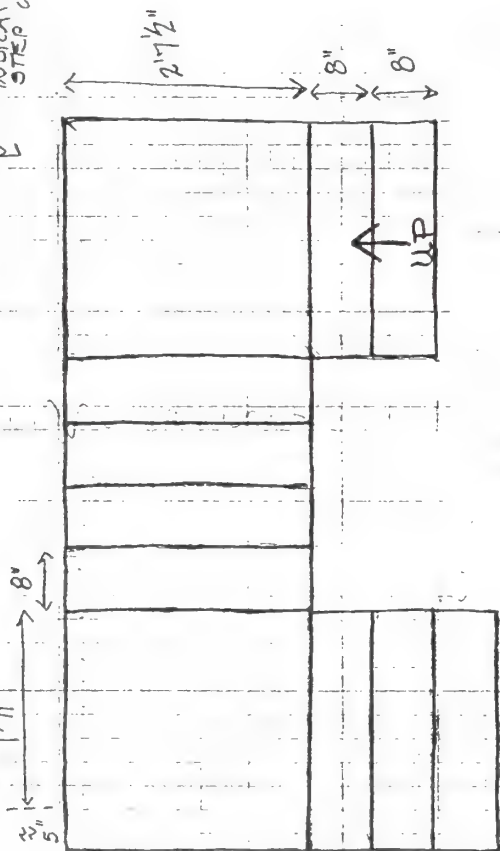
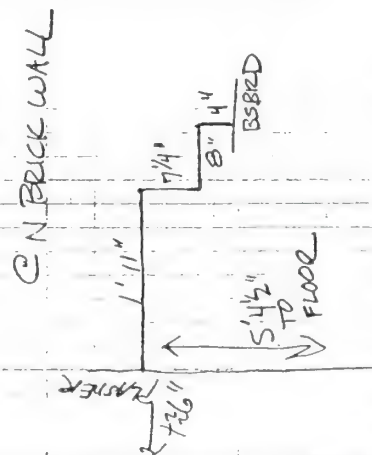
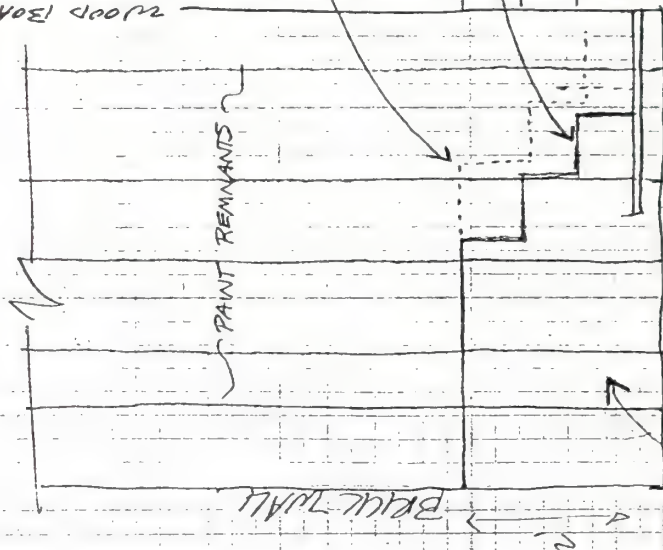
MIMA: MERIAM HS  
RM 101: EVIDENCE OF EARLY STAIRS  
1993-1994. B. Yocum

CONJECTURAL  
APPEARANCE OF  
CA-1705 + CA-1743  
STAIRS

[NOTE: THE ORIGINAL  
(CA-1707) STAIRS IN  
THE FAULKNER  
HOMESTEAD, ACTON, MA  
-- FORMERLY CONCORD --  
ARE OF SIMILAR DESIGN]

EXISTING LANDING  
5' 5"

NORTH WALL  
FORMERLY COVERED  
BY CA-1820 PLASTER

EAST WALL  
BENEATH EXISTING  
CA. 1820 - STAIRS

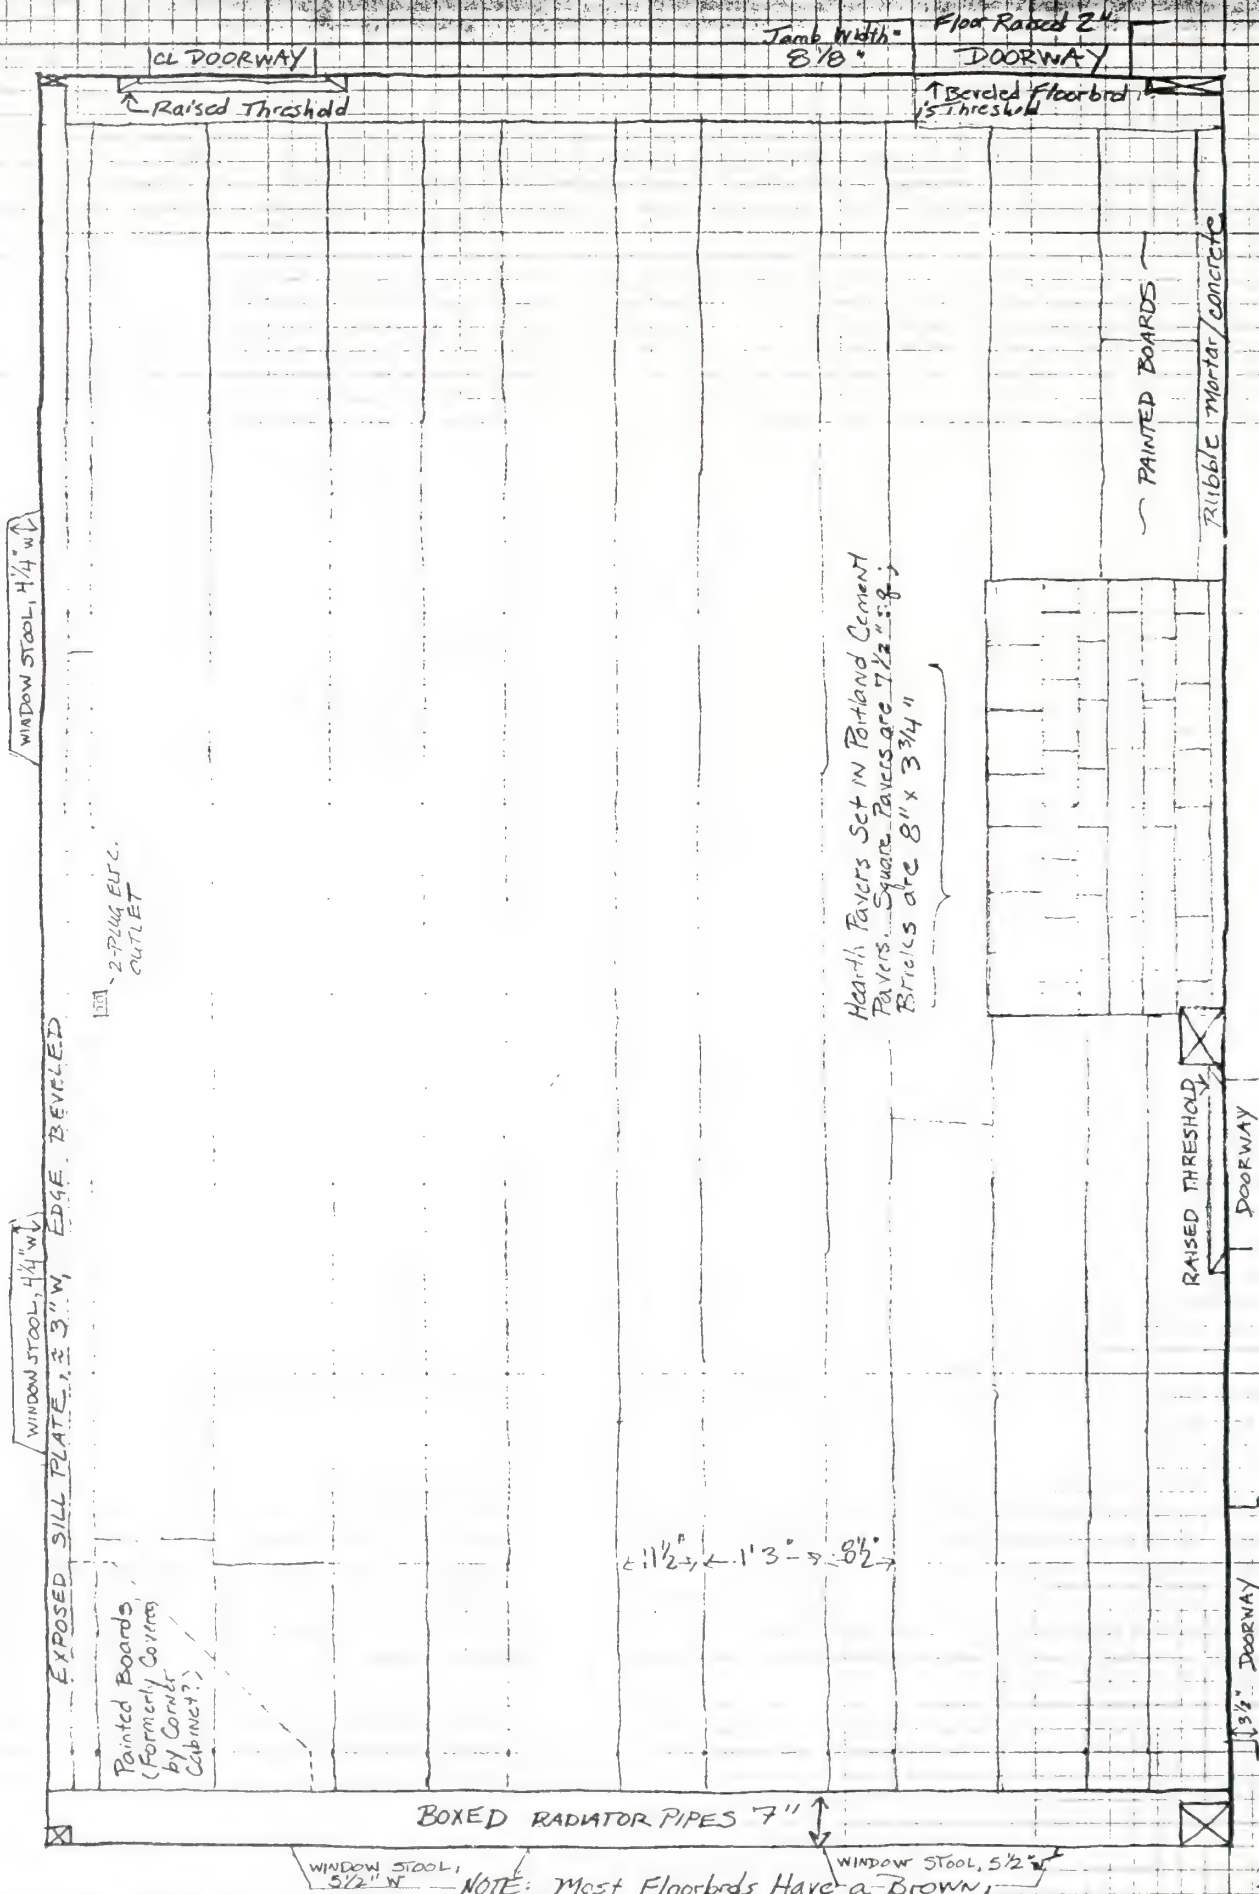
MIMA: MERIAM HS  
 RM 102, FLOOR  
 AUG. 10, 1993; TB. Yocum

NOTE: Most Floorbrds Have a BROWN, Varnished Finish

Large Nail (cut/brought) Bent over; Also, many  
empty Nail Holes, square Profile, No Paint Remnants

All the other floorboards in the room are long lengths in good condition. They range in size from 8 1/2 inches wide to 1 foot 3 inches wide.

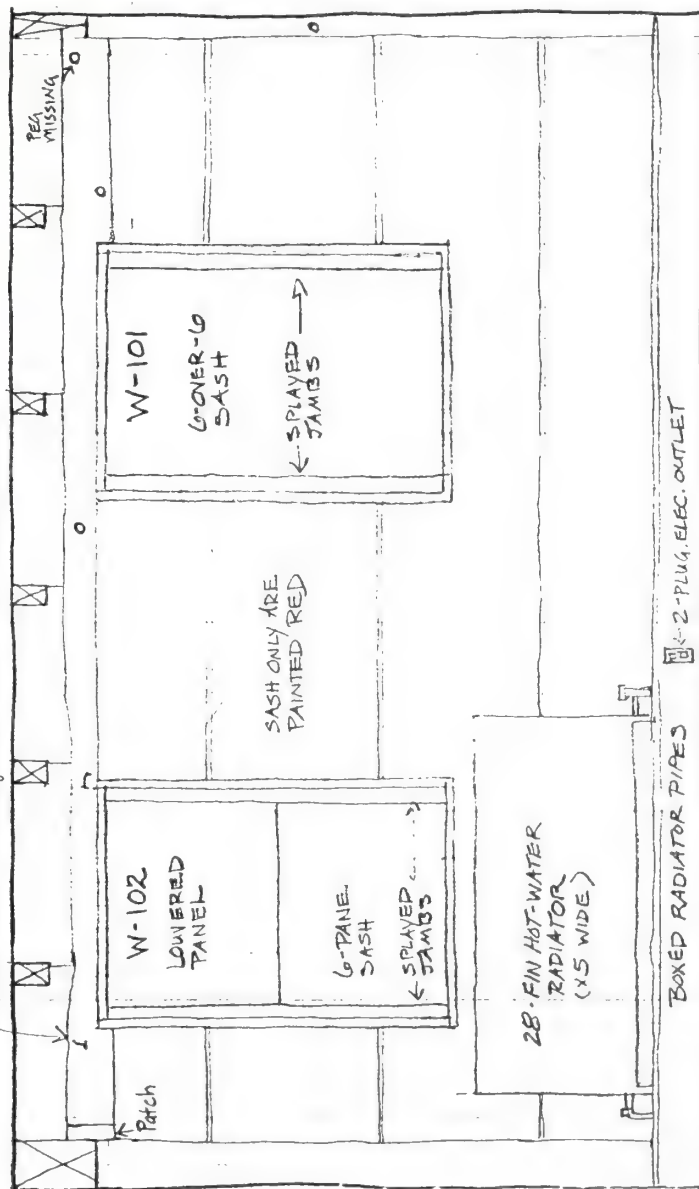
MIMA: MERIAM HS  
RM 102, SOUTH WALL  
Aug. 10, 1993; B. Yocum  
SCALE: 1/2" = 1'0"

BURM. & CEILING DEFLECTS DOWNWARD

PEG IS EXTRUDING

Large Nail (Wrought?), Bent Over

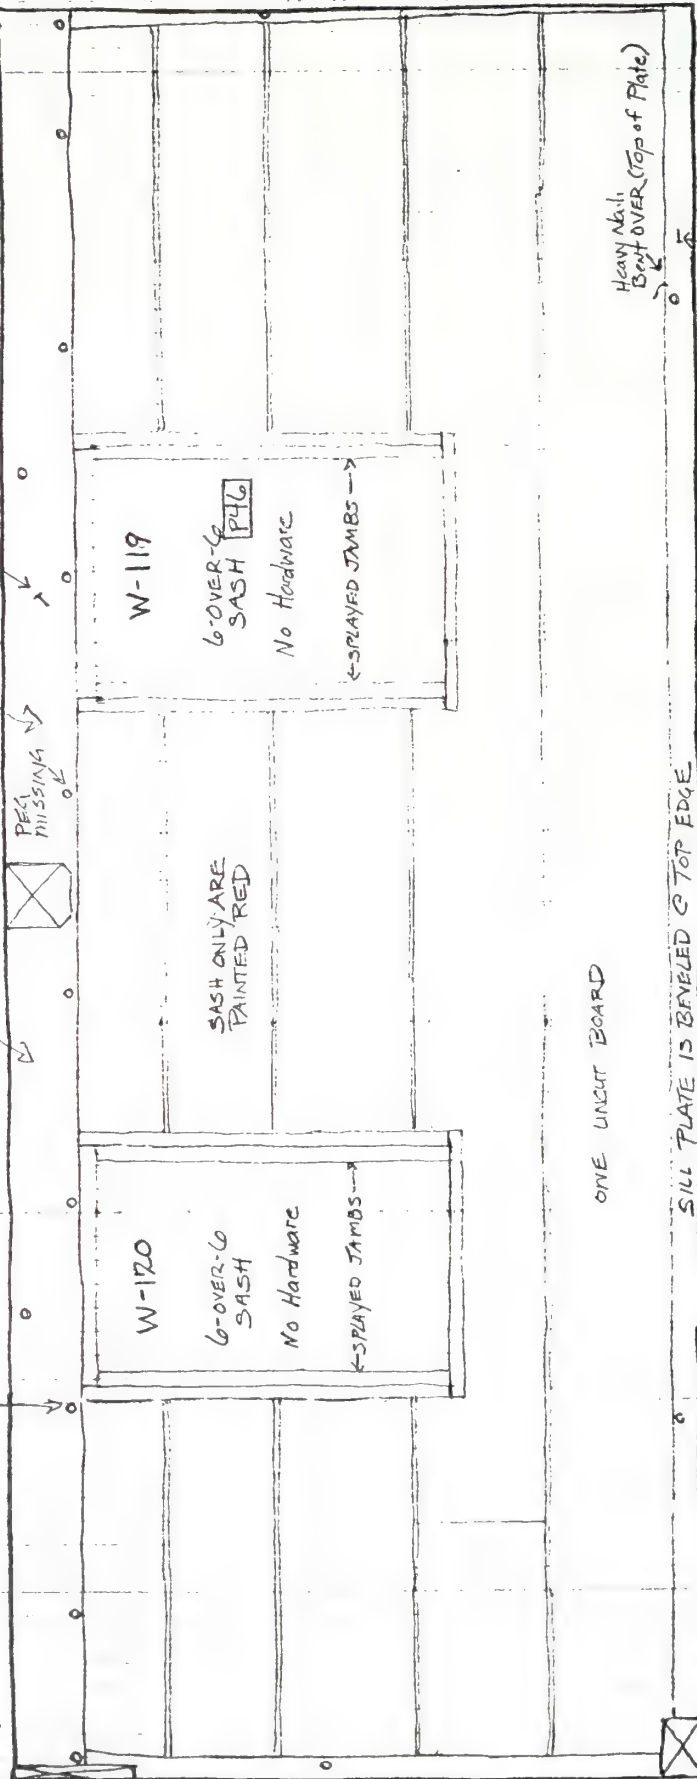
MIMA: MERIAM HS.  
RM 102, WEST WALL  
Aug. 10, 1993; B. Yocum  
SCALE: 1/2" = 1'0"

HORIZONTAL BRADED PINE PANELING ATTACHED WITH CUT NAILS; EXTRANEAS WROUGHT NAILS HAVE BEEN ADDED. NO REMNANTS OF PAINTED FINISH. Empty square-profile nail holes, indicating false. LOOKS HAND-PLANED.

Paneling width in Room varies, 8" - 1' 8 1/4"

The hewn post-and-beam framing of the west wing is exposed in Room 102 at the walls. Here may be seen the raised sill at the west wall, the one-story corner posts, and the upper girts. Except for the chimney girt, however, none of this framing was intended to be exposed as it is today. This is based on the absence of paint remnants on the framing members, and the presence of empty square nail holes and bent-over wrought nails that formerly attached wall paneling to the framing. See "Missing Paneling" for details.

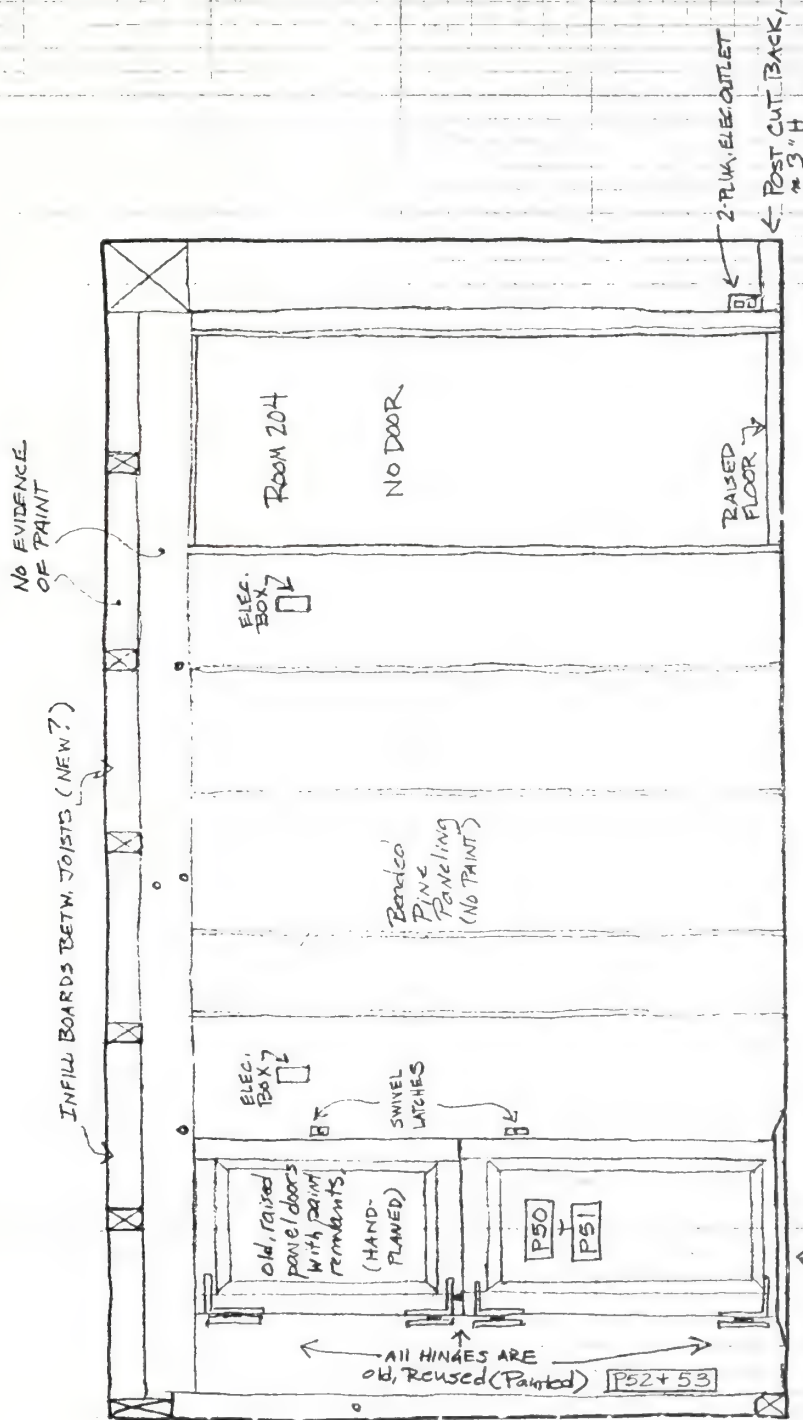
MIMA: MERIAM HS  
RM 102, NORTH WALL  
Aug. 10, 1993; B. Yocum  
SCALE: 1/2" = 1'0"

All Woodwork is Varnished

DOOR MEASUREMENTS:

Paint Remnants, Sides + Underside  
of Beam. Also extant are nails + Empty  
NAIL HOLES.

A doorway without a surround at the west end of the north wall leads to a shallow closet. The closet projects into Room 103, in the circa-1810 kitchen wing. The doorway opening is obviously not original, because a corner brace once existed here as part of the house frame. (A wooden peg from the missing brace remains in the northwest corner post). It is unlikely that the

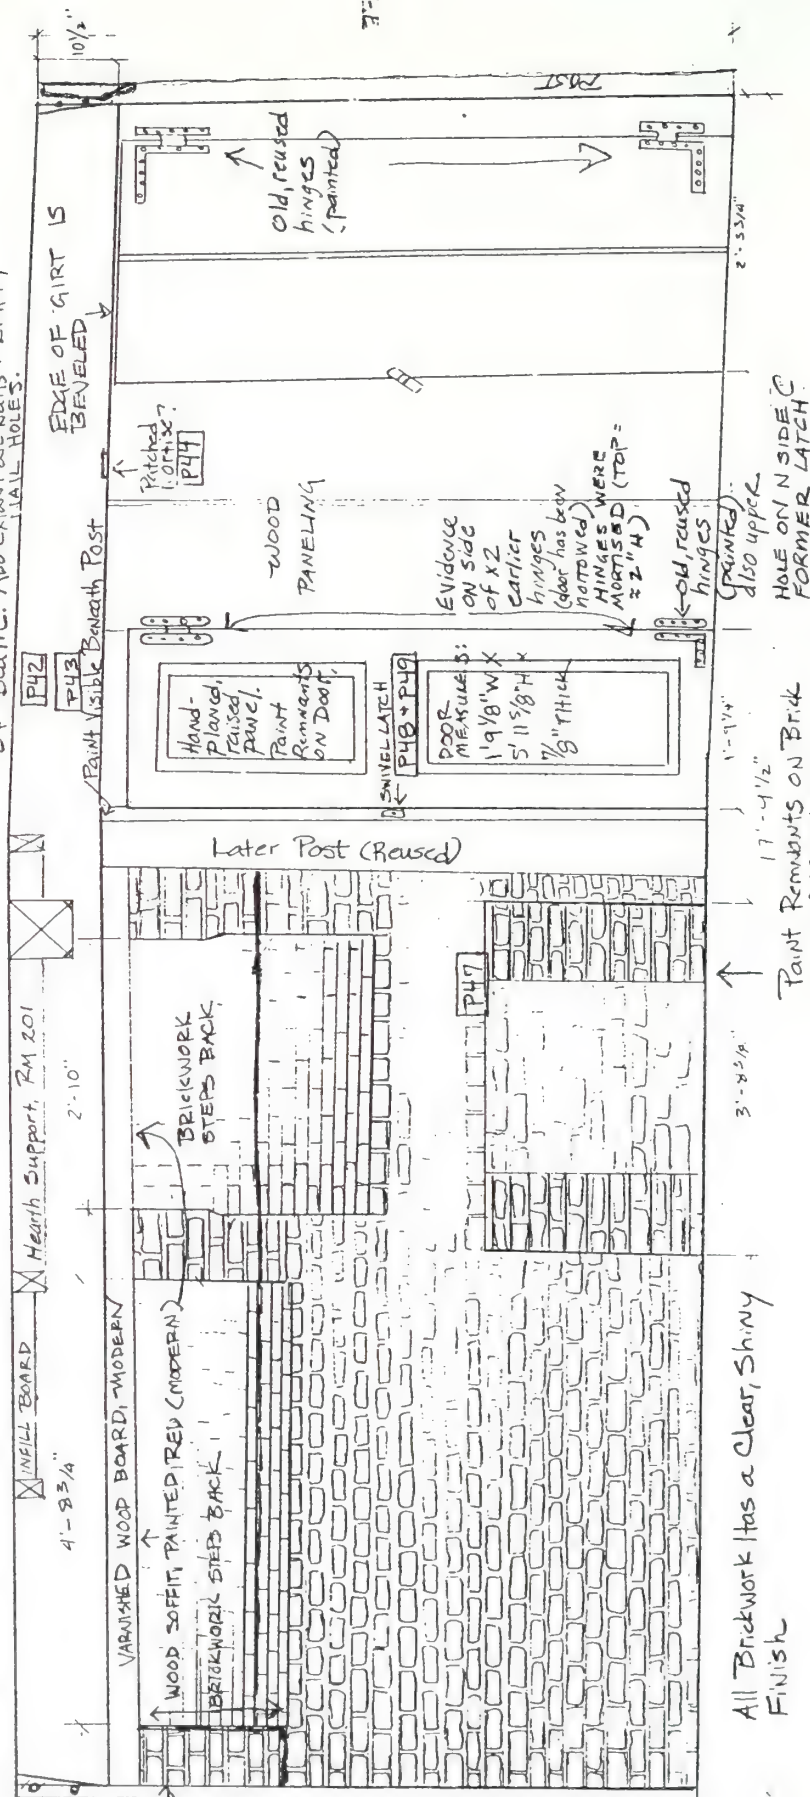
NOTE: No Evidence of Stud Pockets (as for an Exterior Wall).

2" side, 4" (2 bricks high)  
top.

BRICKWORK CONTEMP. W/ KITCHEN FIREPLACE?  
BRICKS ARE 7 1/2" x 2" x 3 1/2"

The existing firebox is offset to the south side of the large expanse of brickwork, making it roughly centered at the east wall. It is small: the opening, which is supported by an iron-bar lintel, measures 2 feet 4 inches high by 3 feet 6 inches wide by 1 foot 6 inches deep. The interior side jambs are splayed, and support a gudgeon (for a missing crane) on the south side. This fireplace is believed to date to the circa-1743 rebuilding of the chimney.

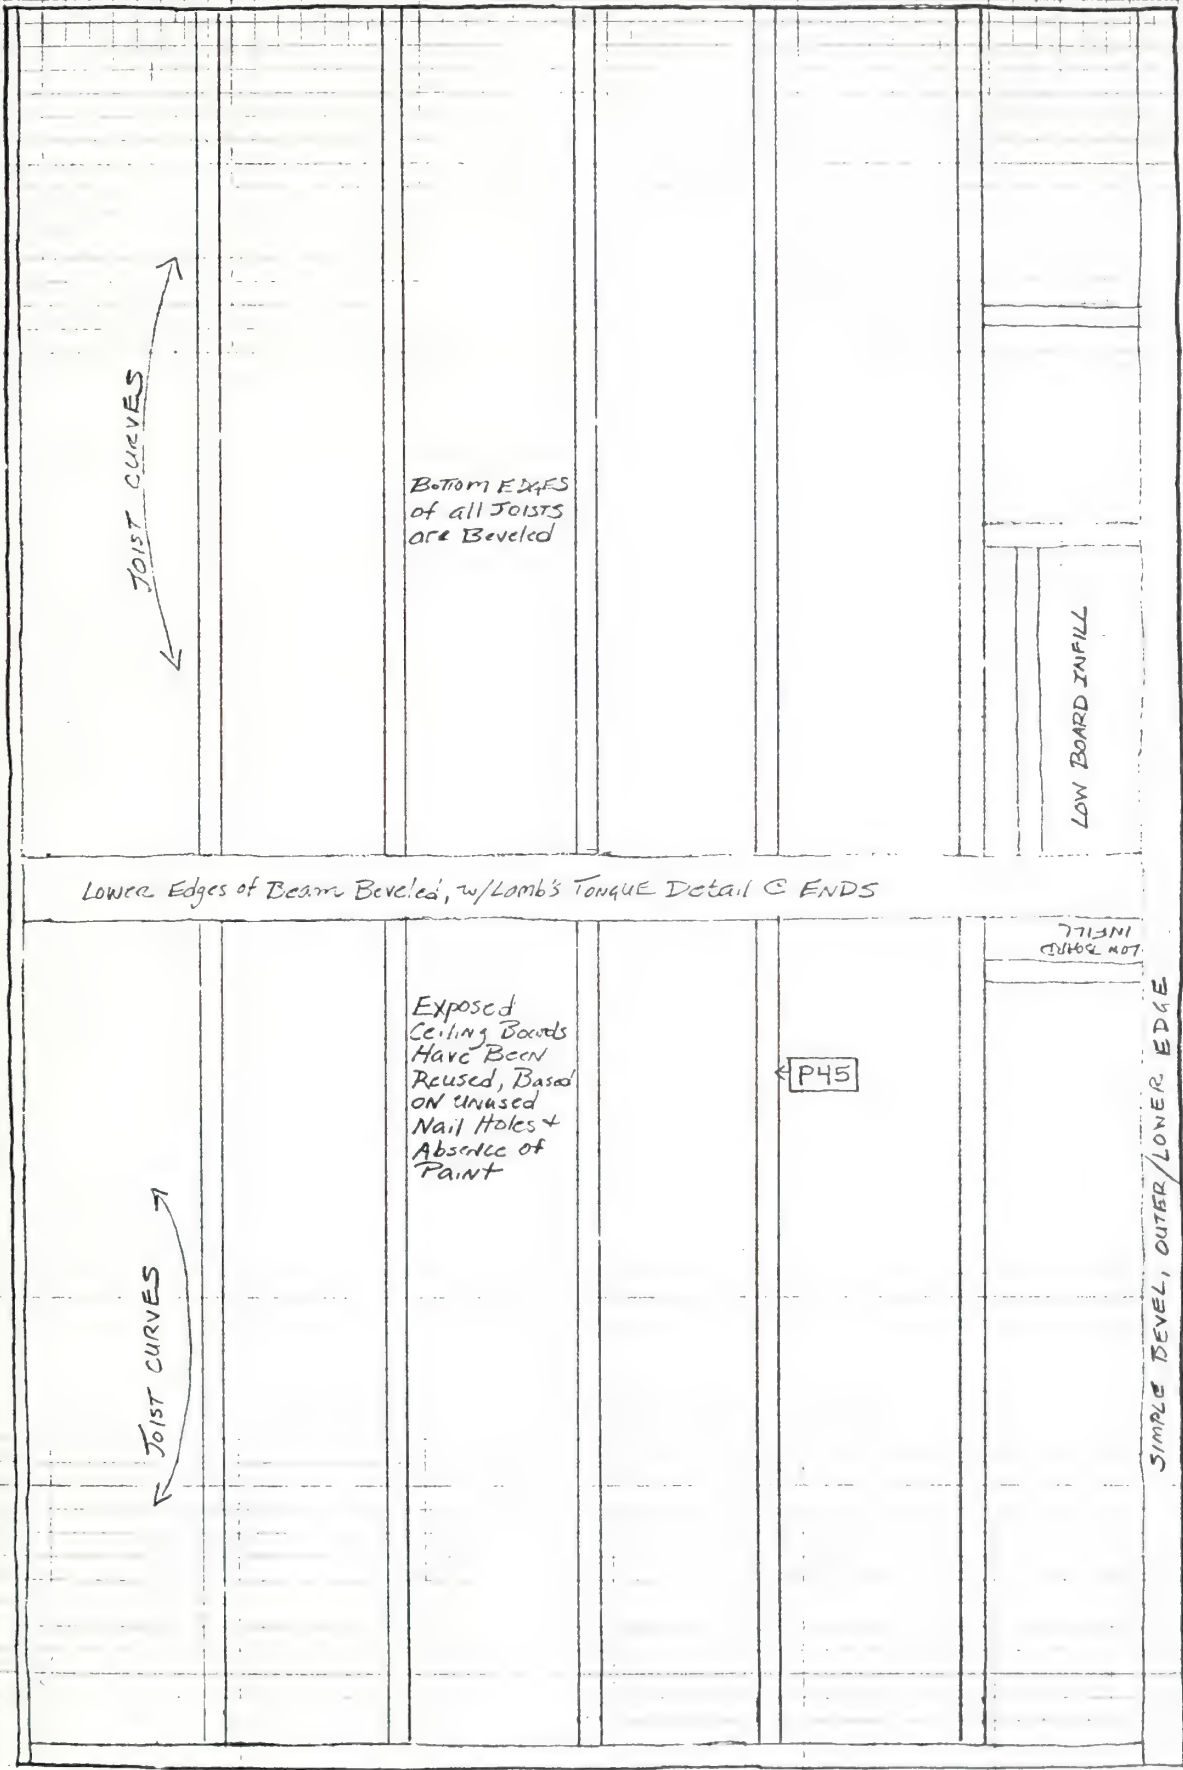
MA: MERIAM HS  
 2M102, CEILING  
 6.10.1995; B.yocum

JOISTS MEASURE  $\approx 2 \frac{3}{4}$ " W x  $4 \frac{3}{4}$ " Deep  
 PAINT REMNANTS ON CTR. BEAM + JOISTS (UP TO CEILING BOARDS);  
 ALSO EVIDENCE OF FORMER PLASTER CEILING ON UNDER SIDES OF  
 JOISTS (PL STAINS, CUT + WROUGHT LATH NAILS)

Framing details indicate that the ceiling framing was originally (circa 1705) intended to be exposed. These details include the chamfering at the two bottom corners of the summer beam, the east chimney girt, and all the joists. Special decorative carving is also found on the summer beam, where the chamfering at both the east and west ends is terminated with a lamb's-tongue detail and an incised diamond-shaped stop.

Physical evidence of the later plastered ceiling survives on the undersides of the joists. This includes white plaster stains and lath nails. The remaining lath nails are a mixture of hand-wrought and machine-cut types, suggesting that the ceiling may have had two plaster ceilings—one installed sometime before 1800, and one sometime later (circa 1820).

The earliest painted finishes in the house were discovered on the framed ceiling in Room 102. Here it was found that the ceiling had been originally finished with a mustard-yellow, lead-based paint, over which had been applied a decorative design in black. Faint remnants of this design, which is abstract and curvilinear, may still be seen on the sides of the chimney girt and the summer beam.

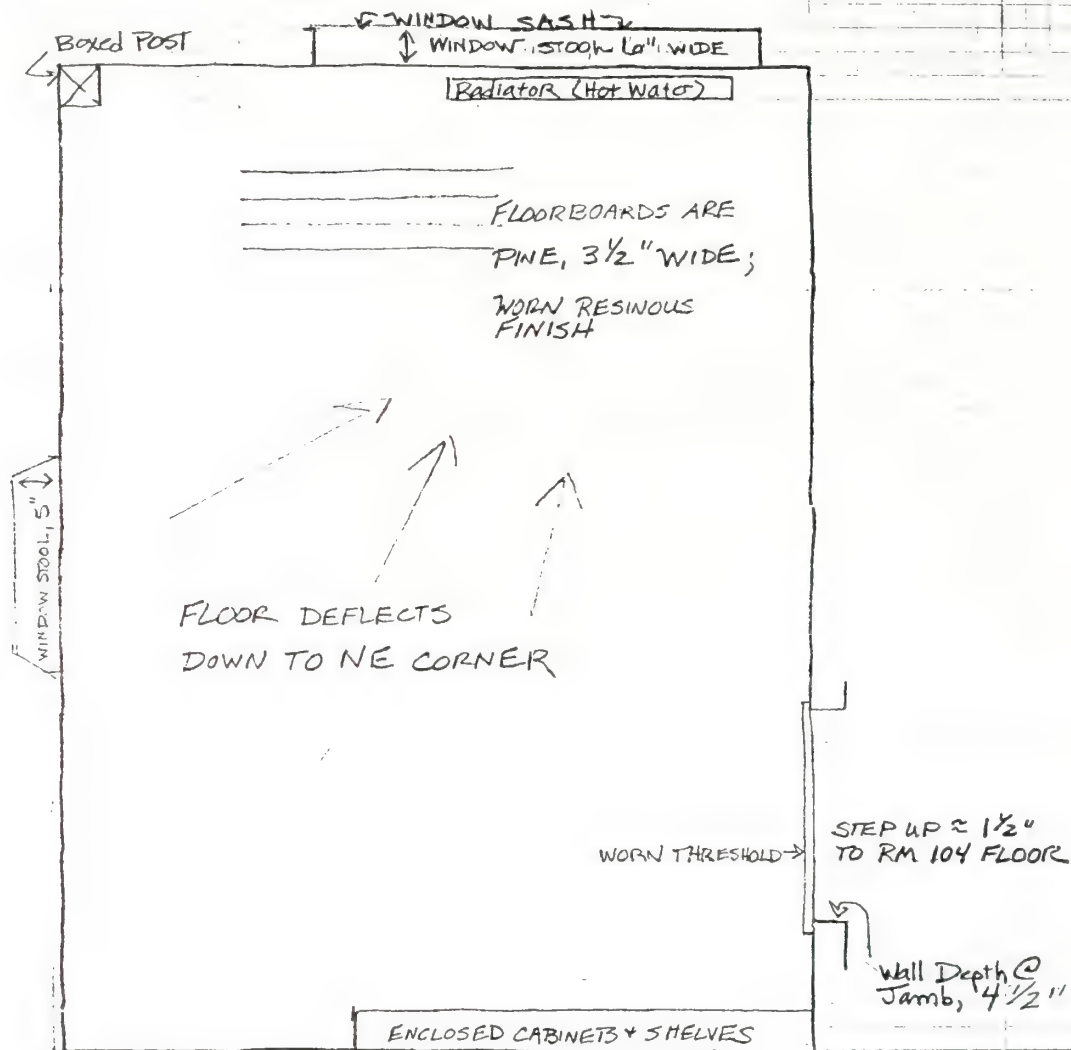
FLOOR IS MOSTLY COVERED BY A  
LOOSE RED CARPET

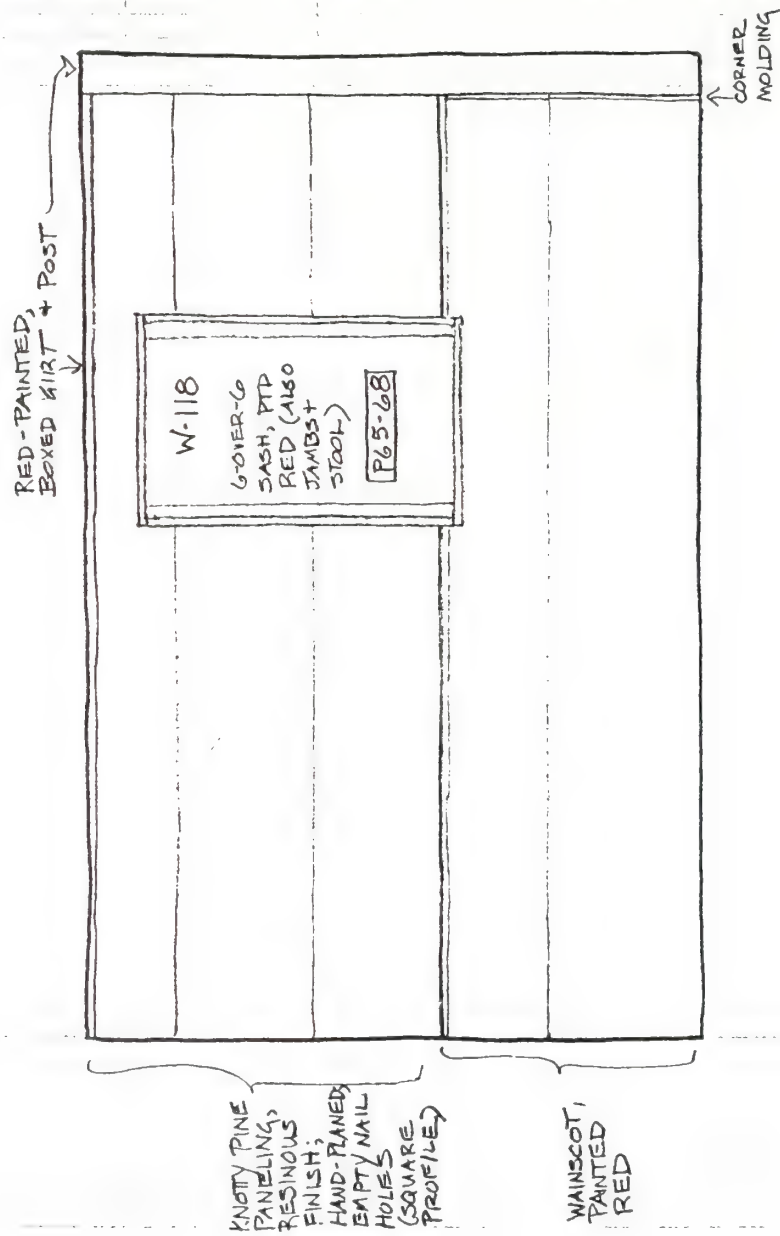
THIMA: MERIAM HS  
RM 103, WEST WALL  
Aug. 13, 1993; B. Yocum  
SCALE: 1/2" = 1'0"

CEILING & FLOOR DEFLECT DOWNWARD

BOXED POST, W/ CORNER BEAD, PTD. RED

BOXED 4/1 RT, W/ EDGE BEAD (LOOSE @ E. END), PTD. RED - [P64]

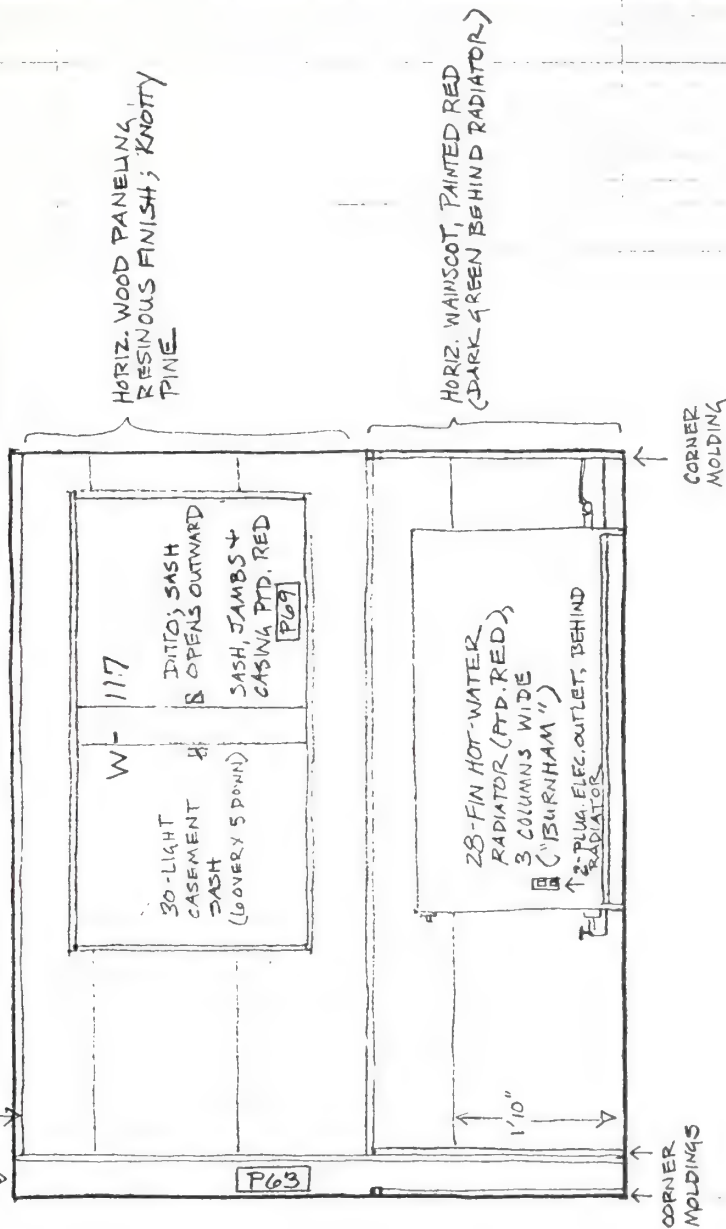
THIMA: MERIAM HS.  
RM 103, NORTH WALL  
AUG. 13, 1993; B. Yocum.

SMALL DOOR, OF PINE PANELING, WITH BRASS KNOBS, BUTTERFLY HINGES, WOOD SWIVEL LATCH; MEASURES 11" W x 1'3" H x 7/8" THICK. OPENS ONTO GLASS PANEL THAT SHOWS BACK SIDE OF RM 104 WOOD LATH + PLASTER.

BOXED 4IRT

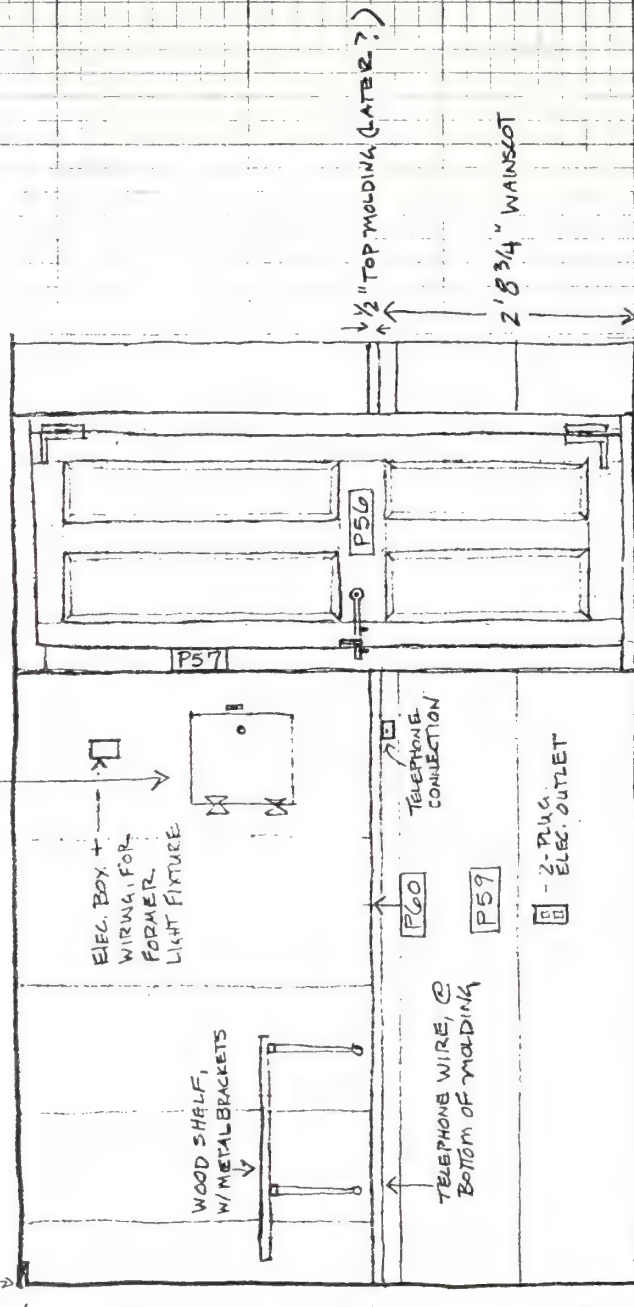
MIMA: MERIAM HS.  
RM 103, EAST WALL  
AUG. 13, 1993; TS. Yocum  
SCALE: 1/2" = 1'0"

UNPAINTED, KNOTTY PINE PANELING. MEASURES 7 1/2" to 1'9" WIDE. Empty, square-profile Nail Holes indicate Reuse. ALSO LOOKS HAND-PLANED.

WOOD WAINSCOT, PAINTED RED (HAND-PLANED)

4-Panel Door is mortised, Hand-Planed, w/ Raised Panels Both Sides, L-Hinges, + Duffell Latch. Door Appears to be in Original Location, w/ Original Hardware. Door Measurements: 2'6" W x 6'2 5/8" H x 3/4" THICK

The doorway woodwork includes a plain-board surround, a worn threshold, and a mortised door. The door has a hand-planed finish and four panels that are raised and unmolded on both sides. The door measures 6 feet 2 5/8 inches high by 2 feet 6 inches wide by three-quarters of an inch thick.

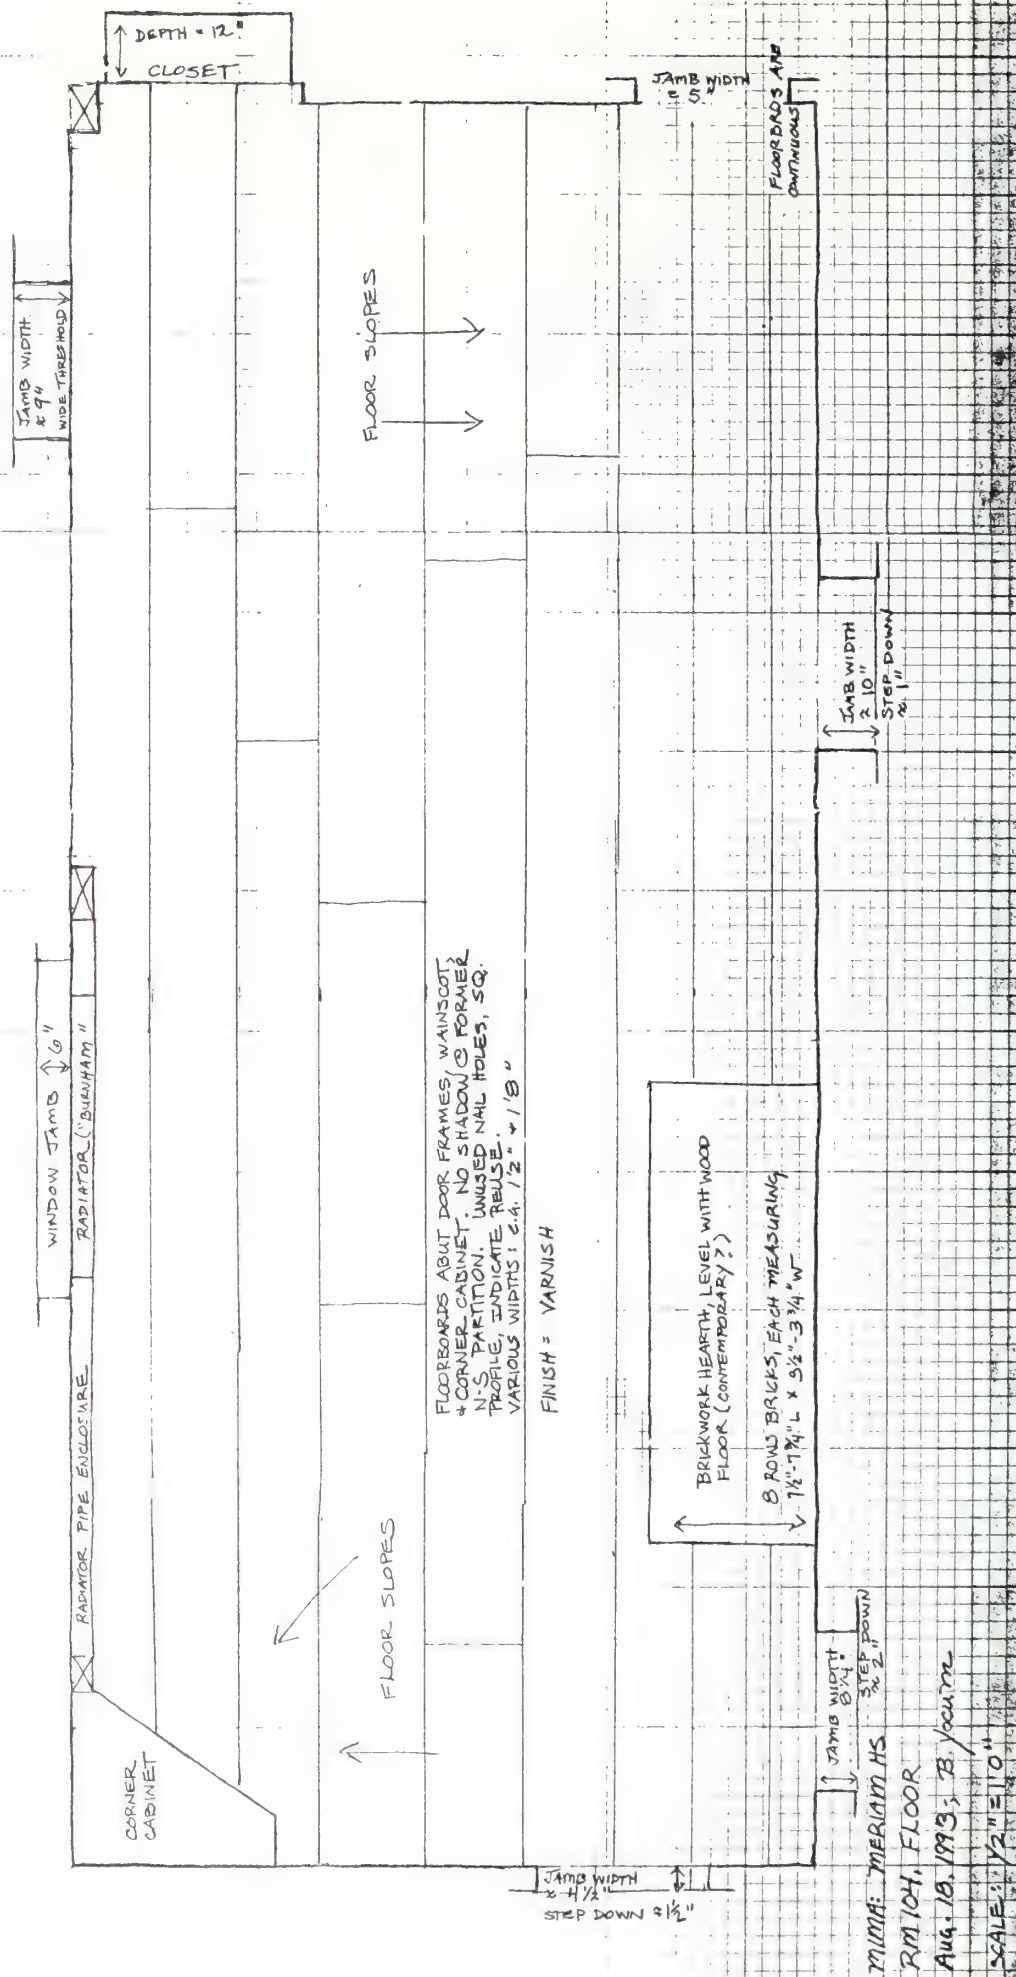
CEILING  $\approx 1''$  LOWER

FINISHES: DOORWAY ELEMENTS  
WAINSCOT + CORNER CABINET ARE  
PAINTED RED; PLASTER ON  
WOOD LATH IS PAINTED WHITE.

PLASTER: OLD IS BROWN; REPAIR IS WHITE;  
1<sup>ST</sup> FINISH ON EARLY PLASTER  
IS GREEN. LATH EXPOSED IN  
RM 103 APPEARS TO BE  
ACCORDIAN-TYPE.]

The old plaster may be distinguished from the later repair plaster by being brown and coarse in texture (instead of white and smooth in texture). Brown plaster survives at the west wall, at the west end of the south wall, and at the south wall between the fireplace and the doorway to Room 108.
